JRC NRD-535(DG) **Improved alignment for ECSS**

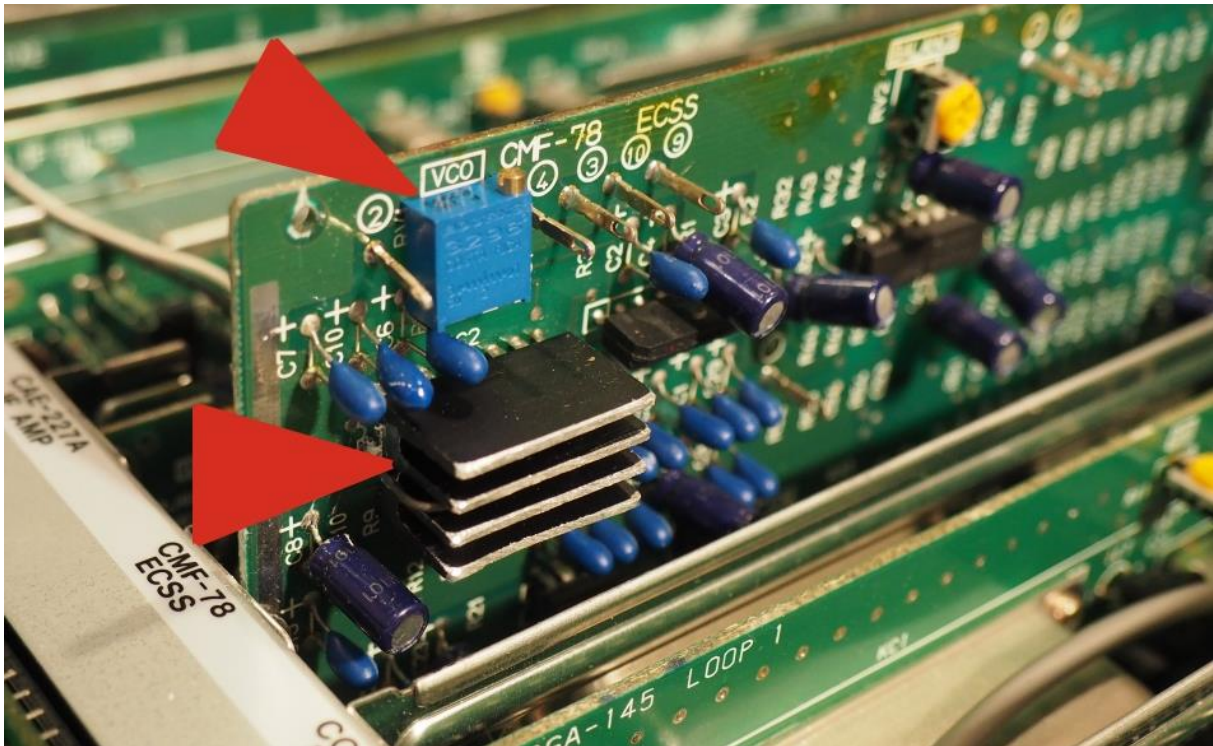
One reason is the thermal instability of the PLL-IC (IC2) MC14046, which has a power dissipation of app. 500mW(!) acc. to the data sheet. So it seems to be a good idea to use a small heat sink for DIP 16 ICs with a clip – see picture 1.

Picture 1: Heat sink for IC2 (PLL) and new multi turn trim pot RV1

Be careful with the clip, which has to be clipped under the IC, and avoid contact with the pcb and its wires. Had to cut the heat sink, because it was a little bit too high for the small space. A small drop of thermal grease will help. Hope this will increase the thermal stability. Additionally I replaced RV1 by a multi turn trim potentiometer.
