Restoration of an ICOM IC-201

2m Allmode Transceiver from the “Seventies”

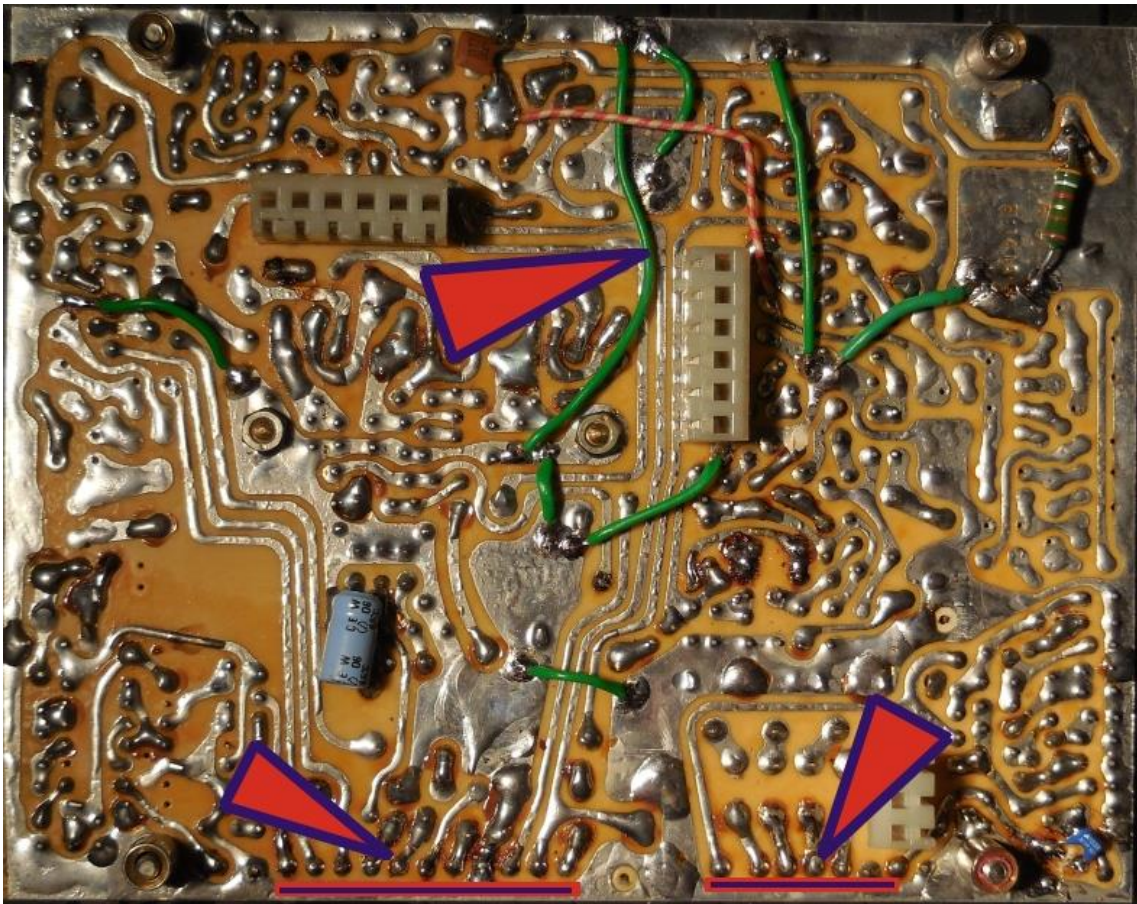
Additional ground wires (green) and resoldered pinheads on the AF-Board

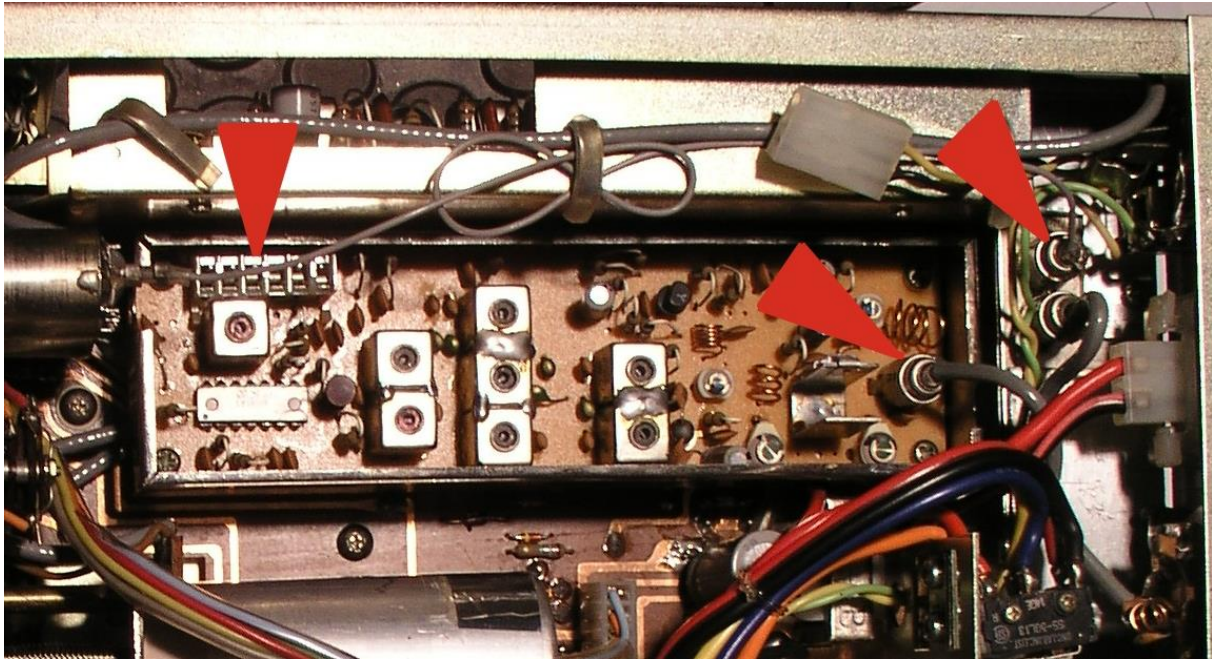
These bad plugged connections on the TX-Mix board caused low output

Boards with plugged connections can easily be removed but over the years they may degrade. Check ALL plugged connections; for coax connectors also check the center conductor! Clean/deoxit them and bend the counter contact back into the right position if necessary.

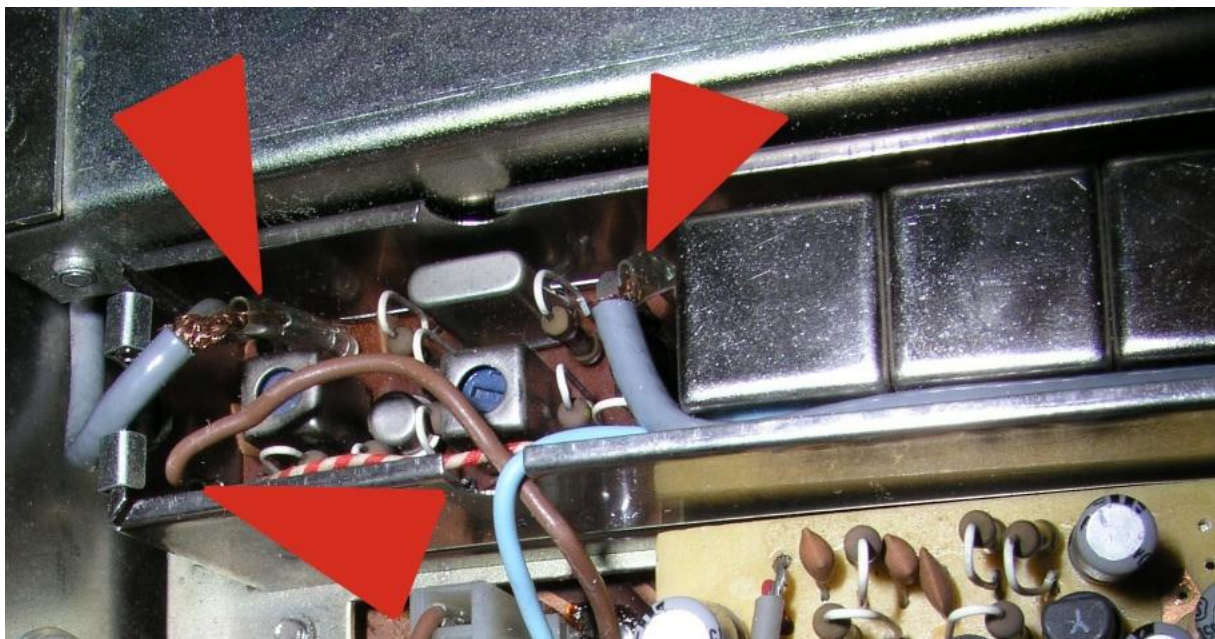
The deaf receiver was caused by bad coax connectors in the RF-Unit
